RE: 988 Halekauwila St., Ward Village Land Block 5, Project 1 "Ke Kilohana" (Block O)
Notice of Warranty Claims for Construction Defects

**Warranty Claim
February 28, 2020**

Site Observation Report

To	Howard Hughes Corp.	SOR No	Warranty Review
Attention	Larry Schenk	Date	Feb. 28, 2020
From	Kevin Luoma, Grant Higa Kawe Humel	Email	Kevin.luoma@wsp.com, grant.higa@wsp.com, John.humel@wsp.com
Project	Ke Kilohana HOA Warranty Review	Project No	B2013460
Copies		No. of pages	9

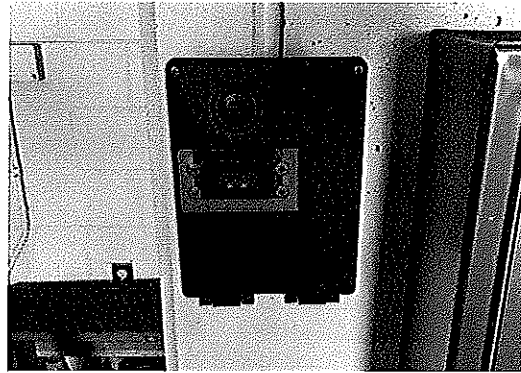
8. Unsure if CO monitors are operational within loading dock.

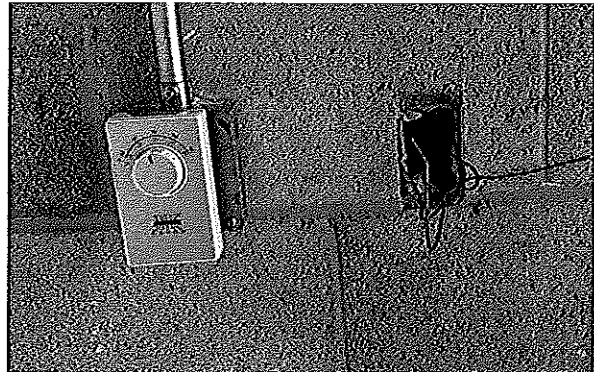
9. T-stat serving EF-12 in Fire Pump room and EF-11 in Level 4 display area does not seem to work properly where it turns on fan we space temperature exceeds setpoint on dial. Fan appear to turn on anytime the setpoint is set above 75F. There is also an open j-box by EF-11 thermostat.

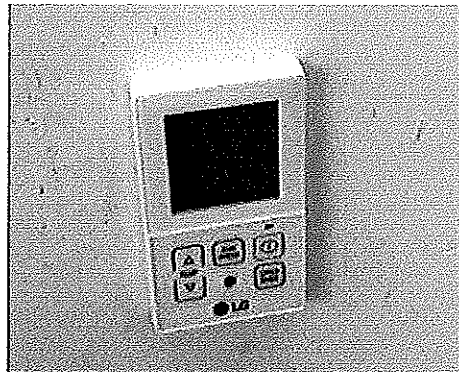
10. FCU-5 thermostat displays error code "CH35" in the residential trash room.

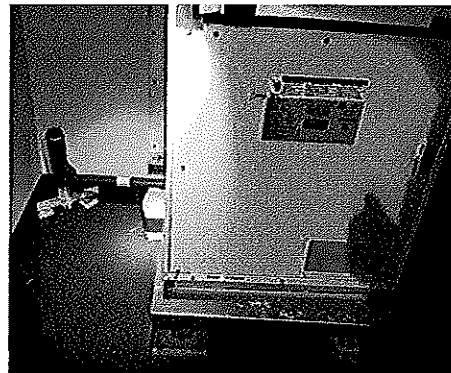
11. VTAC within Theater room had a leak from the drain pan.

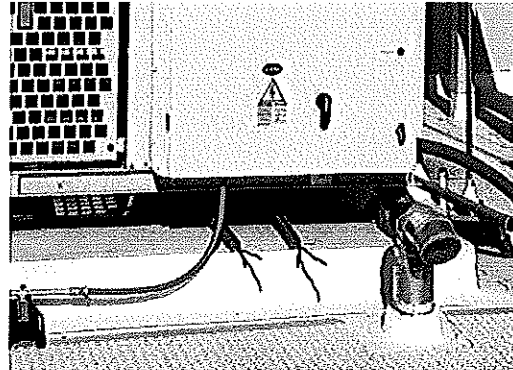
12. Abandoned material under OAU-2.

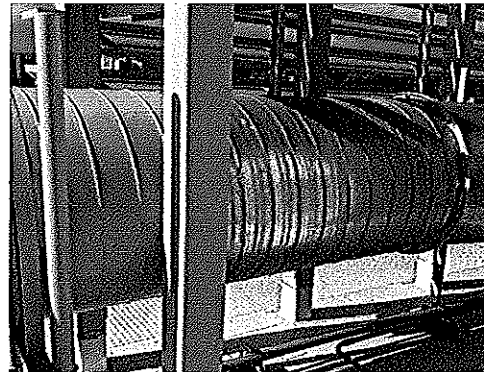
13. Portions of ductwork on roof not painted.

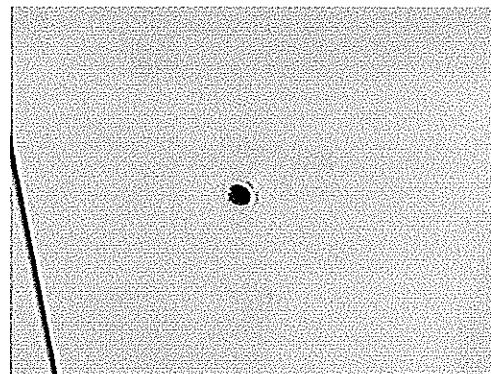
14. Fill in openings on doors of OAU-2.

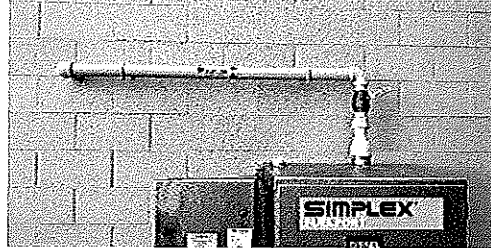
1. Generator fuel filling stating valve not locked in closed position.

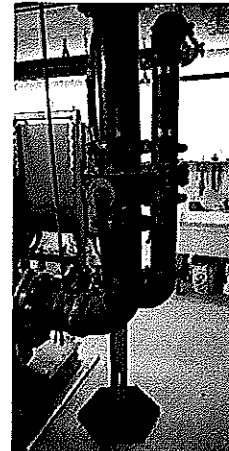
3. No exceptions taken to butterfly valves (BFV) installed on domestic water booster pump outlet. 2006 UPC section 606.0 states valves up to 2" shall be copper, copper alloy, or other approved material (bronze/brass), valves greater than 2" brass or cast iron, and gate / ball valves shall be fullway type. It does not say gate / ball valves only, or that BFV's shall not be used, only that when they are, they shall be fullway (full port).

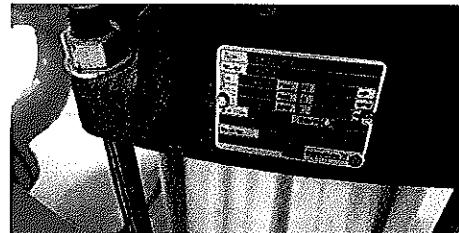
4. Domestic water booster pump (highzone - 100GPM-400TDH) schedule shown on P002 does not match the name plate on domestic water booster pumps installed (high zone - 158GPM-286TDH)

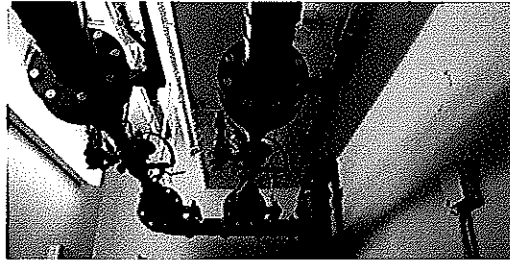
5. Level 8 pressure reducing valve (PRV) station does not appear to be calibrated per P108. Please provide manufacturer's (Cal-Val) calibration and start-up report for all PRV stations (level 8, 15, 22, 29, 36)

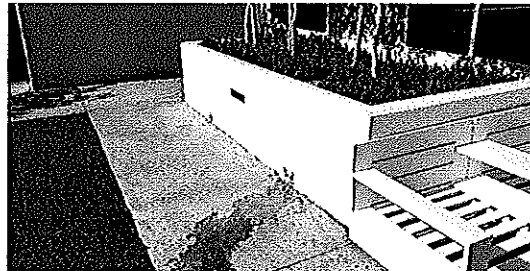
6. Planter drains on Level 8 recreational deck shall connect to storm drain system at Level 7 ceiling per P107. Planter drains shall not discharge to level 8 deck causing nuisance.

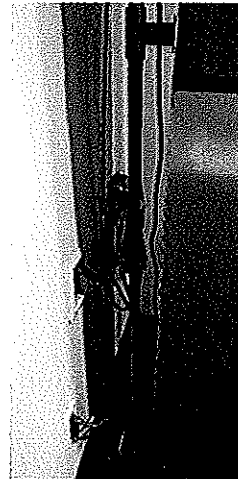
7. Provide ice maker with backflow preventer per 2006 UPC 603.4.12

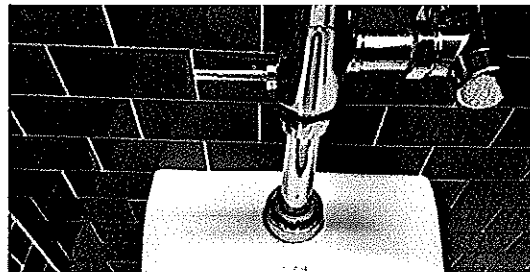
8. Level 8 women's restroom flush valve leaking.

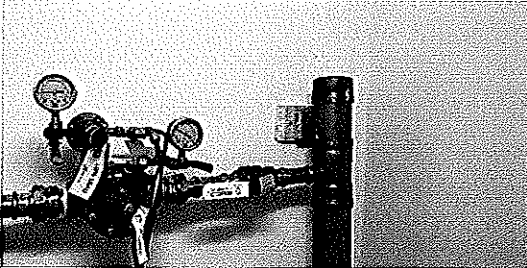
9. Provide proper pipe restraints per 2006 UPC.

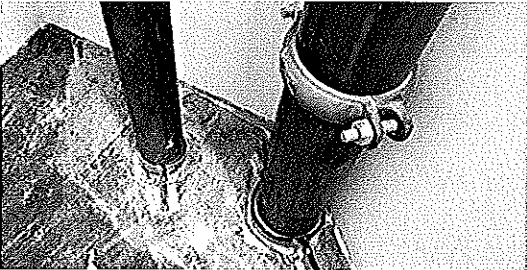
10. Domestic water riser shall have neoprene pad per P502/4

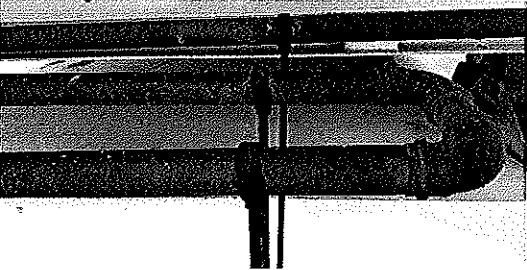
11. Steel clamps on copper piping is not allowed per 2006 UPC. Electrolysis between dissimilar metals occurring on HVAC equipment condensate piping.

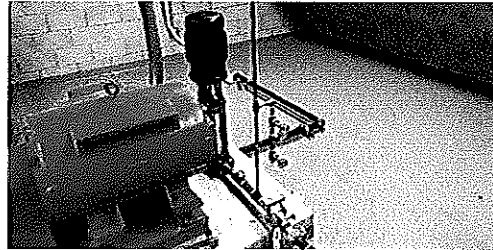
1. Jockey Pump tamper switch does not appear connected.

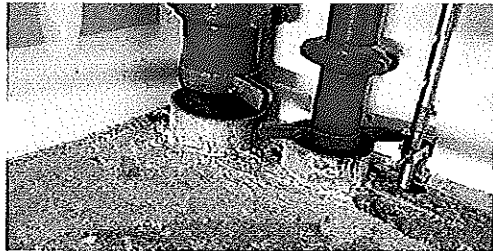
2. Automatic fire sprinkler riser and automatic standpipe riser clamps shall have neoprene pad per FS500/4.

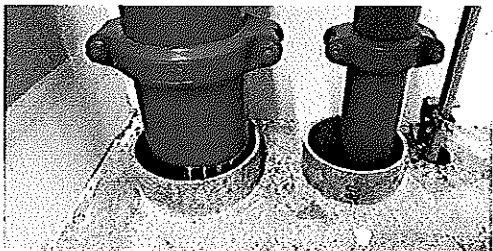
4. Provide riser clamp per FS500/4.

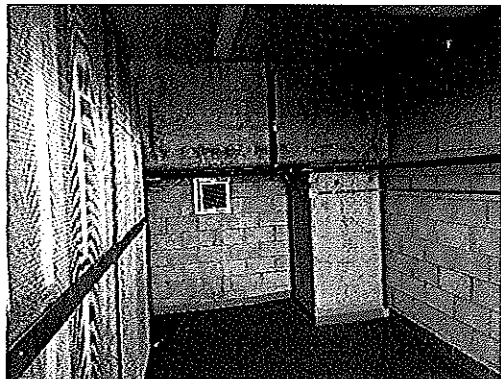
5. Paint exterior fire sprinkler piping at generator intake breezeway

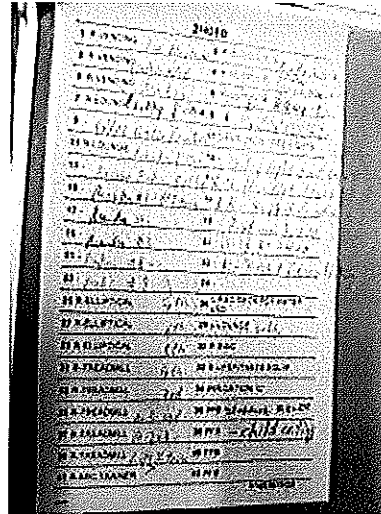
6. General Note: Confirm typewritten panelboard directories matching the as-built circuiting have been posted at all panelboards. It was noted that the directories posted in several of the panels had missing or incorrect entries, notably Panel 2H08B and 2H08L. Coordinate with building management as they have identified some of the discrepancies for panels serving common areas.

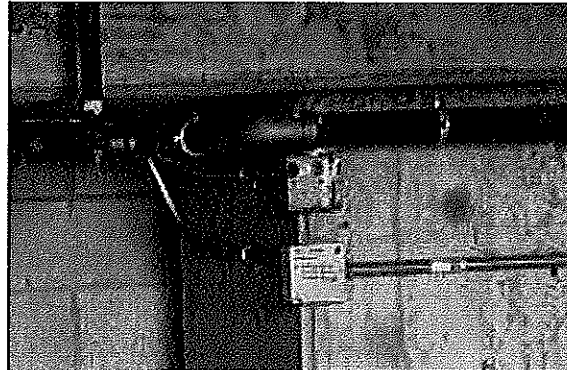
7. It was noted that junction boxes were missing covers in the Residential Trash Room, generator air discharge area, and Elevator Machine Room. Confirm and provide covers as required.
