# Fatal Flaws

## Design and construction defects in Hawaii's concrete decks hurt victims—and builders

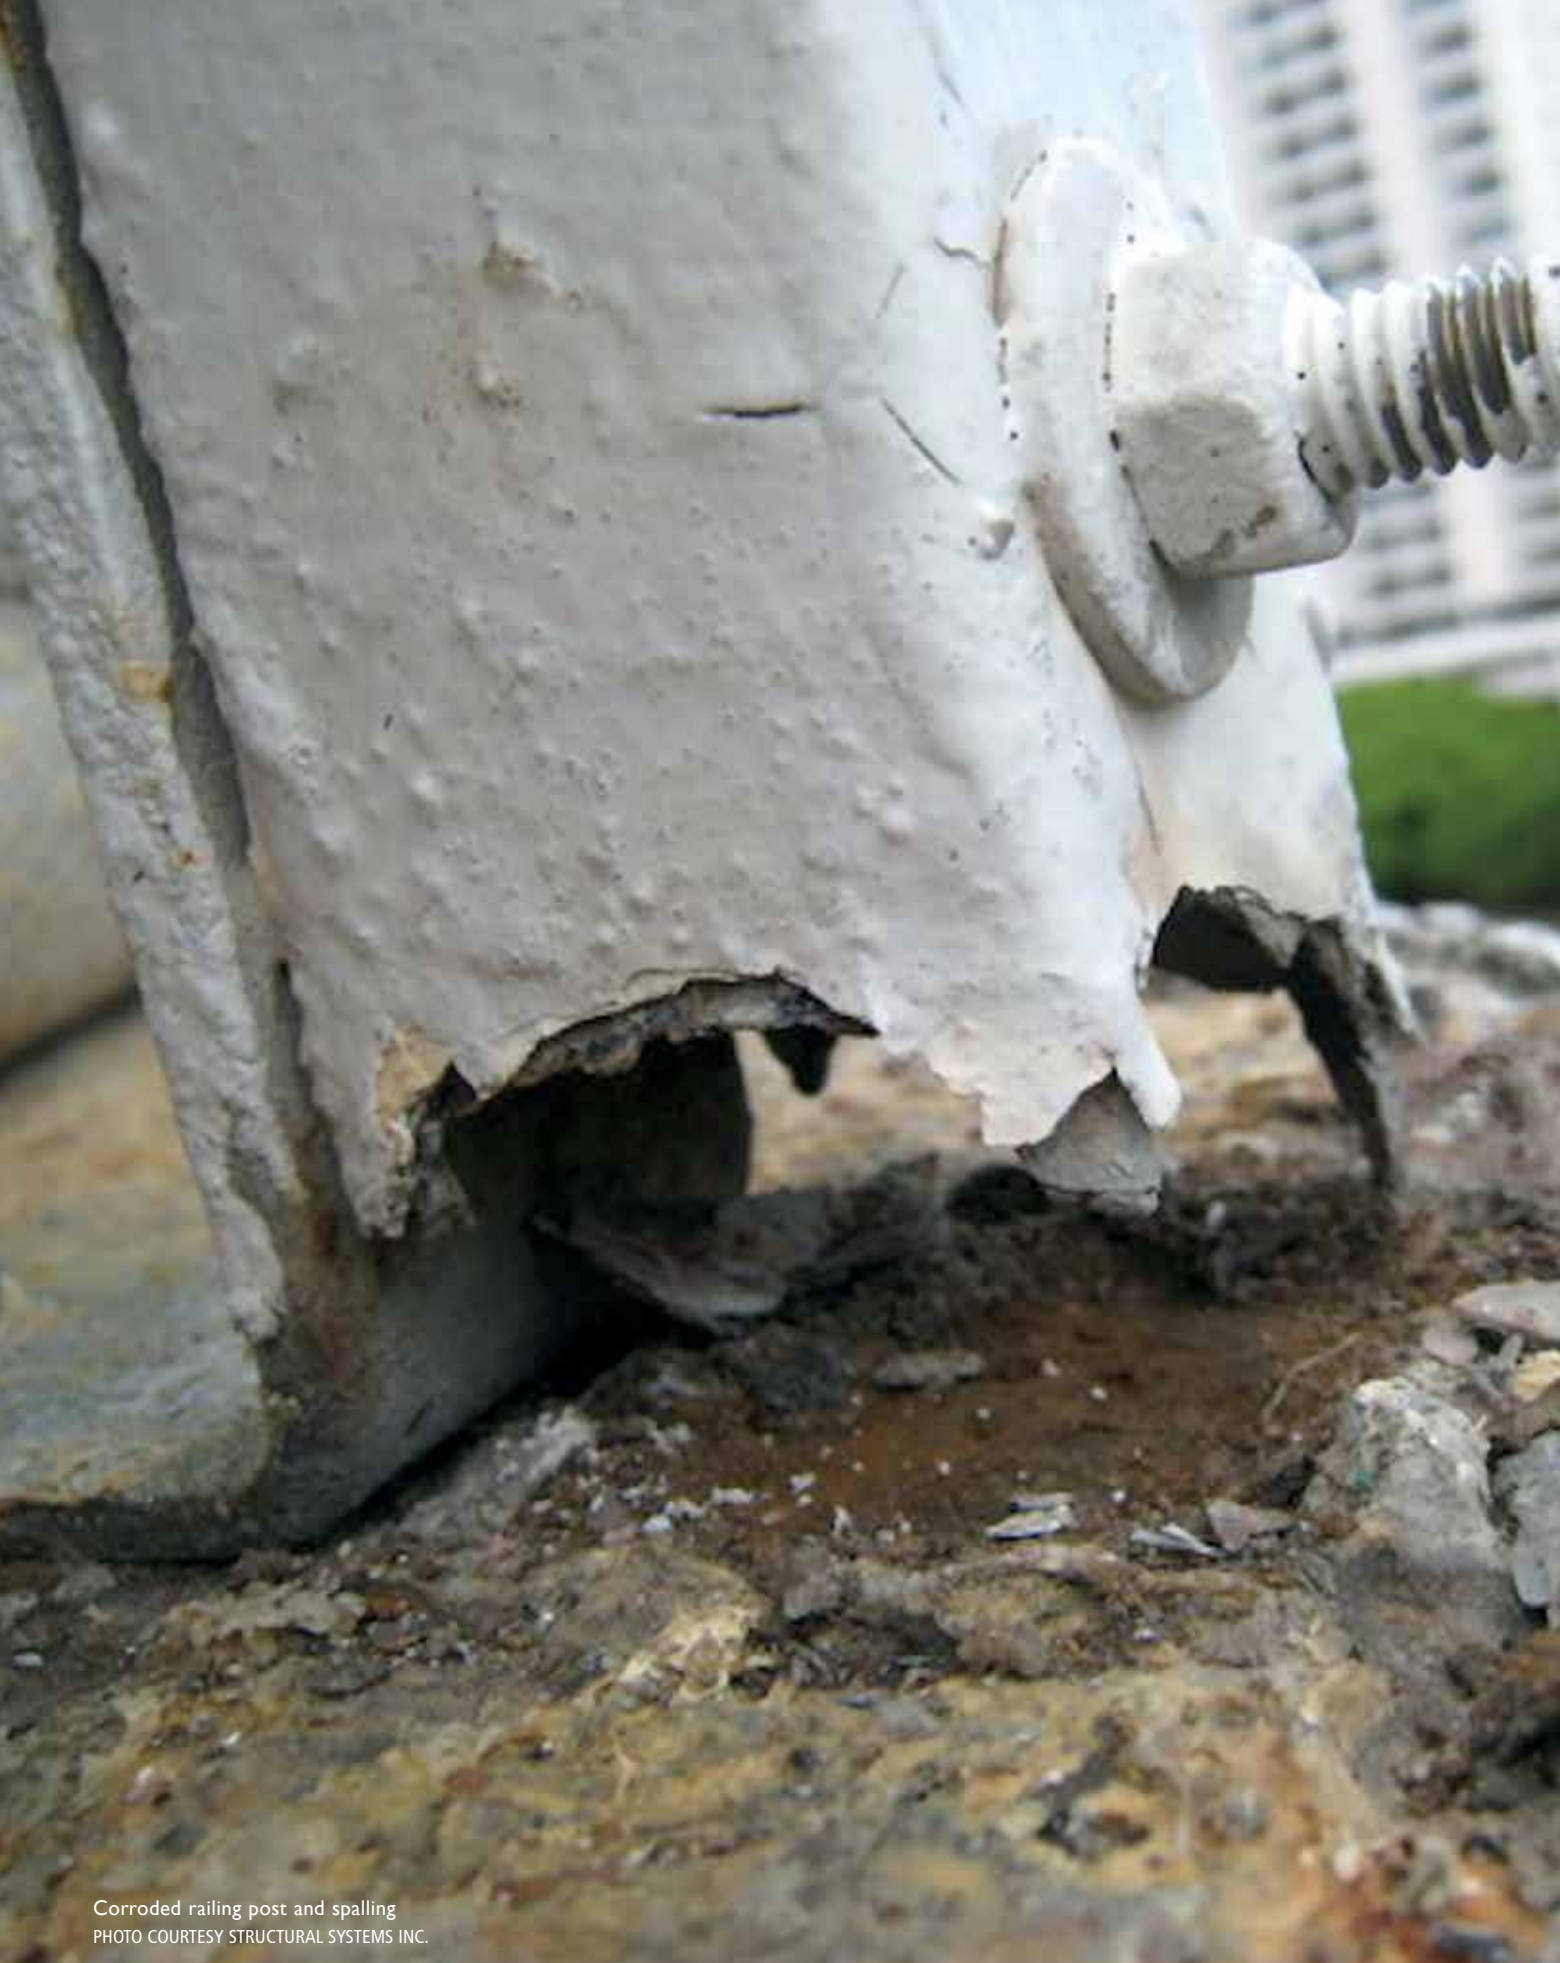
Corroded railing post and spalling  
PHOTO COURTESY STRUCTURAL SYSTEMS INC.

More than one accident has occurred on Hawaii's concrete decks. That's because all concrete platforms in Hawaii—lanais, balconies, stairways, even walkways and foundations flush to the ground—are vulnerable to metal corrosion and spalling, a chemical process that destroys concrete.

"With our salt air and rain, the rebar (in concrete) rusts quickly, which expands and breaks off the edge of the concrete," says Don Fernandez,

president of Epoxy Restoration LLC. "Since railings are on the edge of decks, the railing system soon loosens and fails." "We see failures typically at structural connection points, where aluminum rails get tied together with steel screws, where steel rails embed into reinforced concrete," says Damien Enright, president of Structural Systems Inc./Kelikai Inc. "Any location where you have

dissimilar metals coming in contact (aluminum post next to steel rebar), or a metal component next to moisture and salt (chlorides), you will typically see a hot spot for corrosion."

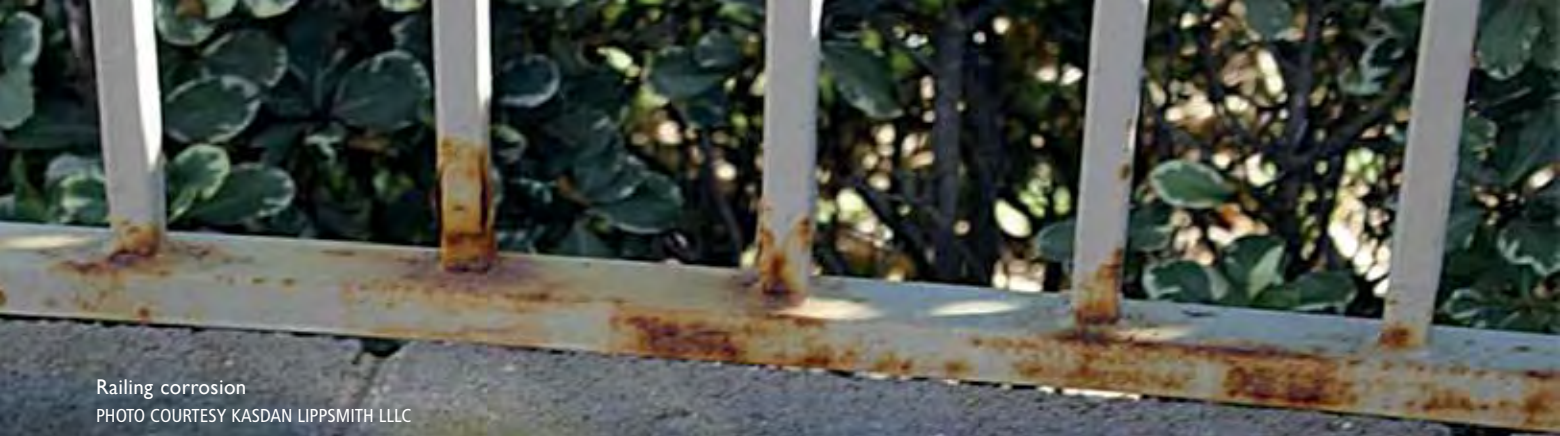
Railing corrosion  
PHOTO COURTESY KASDAN LIPPSMITH LLC

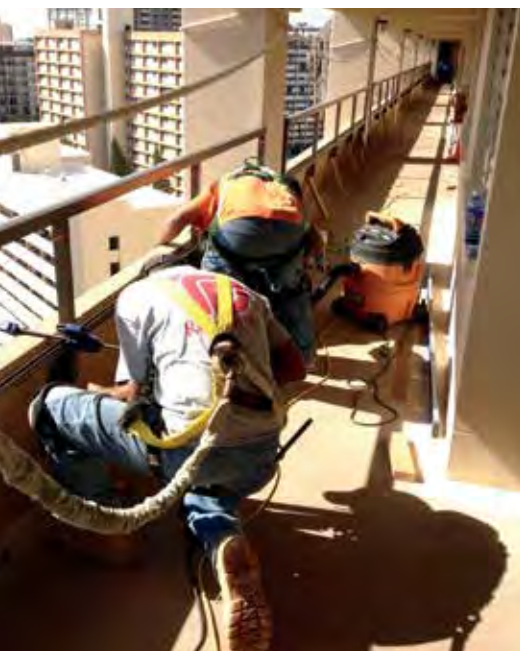
A recent balcony repair by Structural Systems  
PHOTO COURTESY STRUCTURAL SYSTEMS INC.

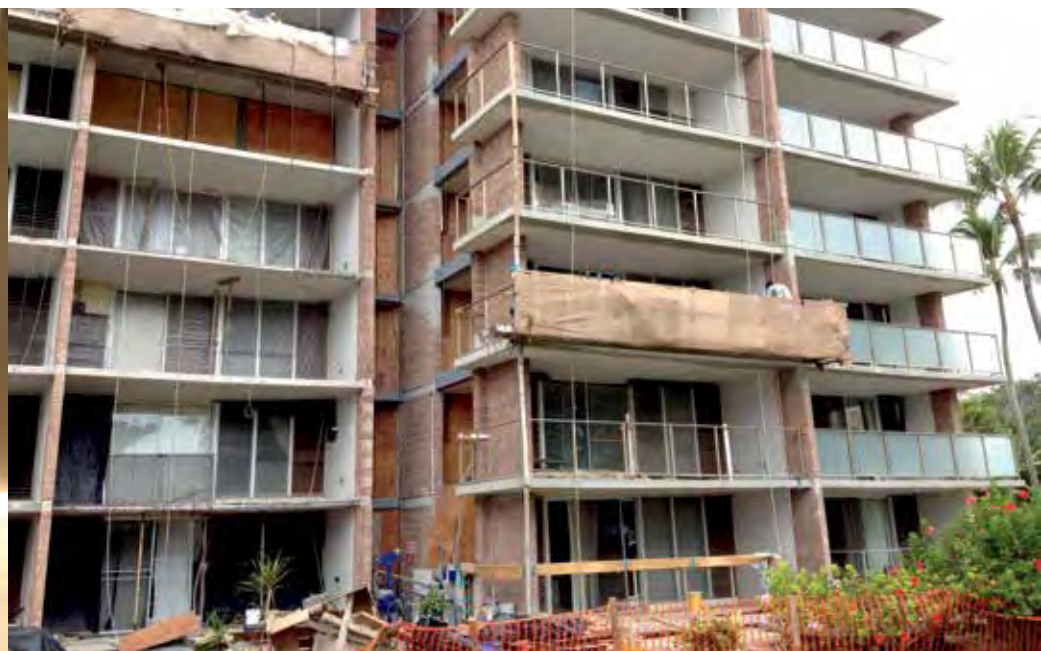
A recent concrete deck and railing repair by Structural Systems  
PHOTO COURTESY STRUCTURAL SYSTEMS INC.

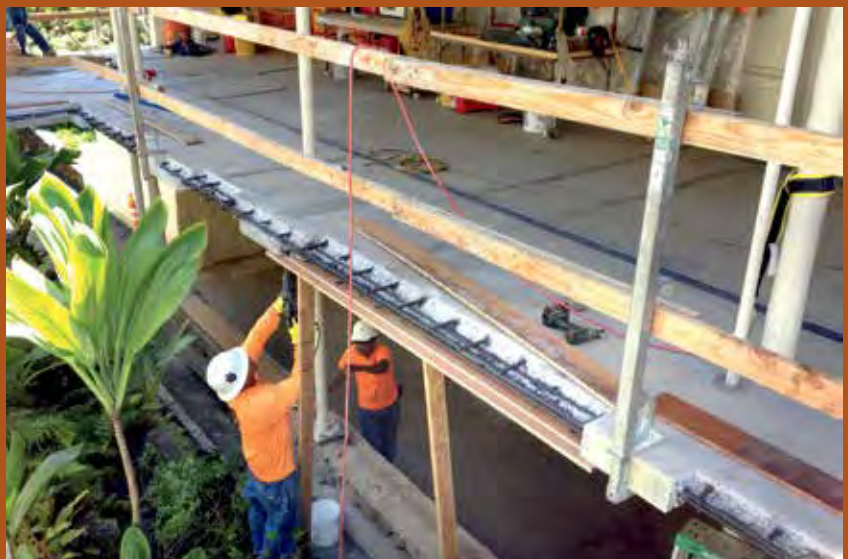
A recent deck repair by Structural Systems  
PHOTO COURTESY STRUCTURAL SYSTEMS INC.
