Inspect Your Railings & Walkways NOW

Hazards in these areas
harm your guests
and usually guarantee
your liability

BY BRETT ALEXANDER-ESTES

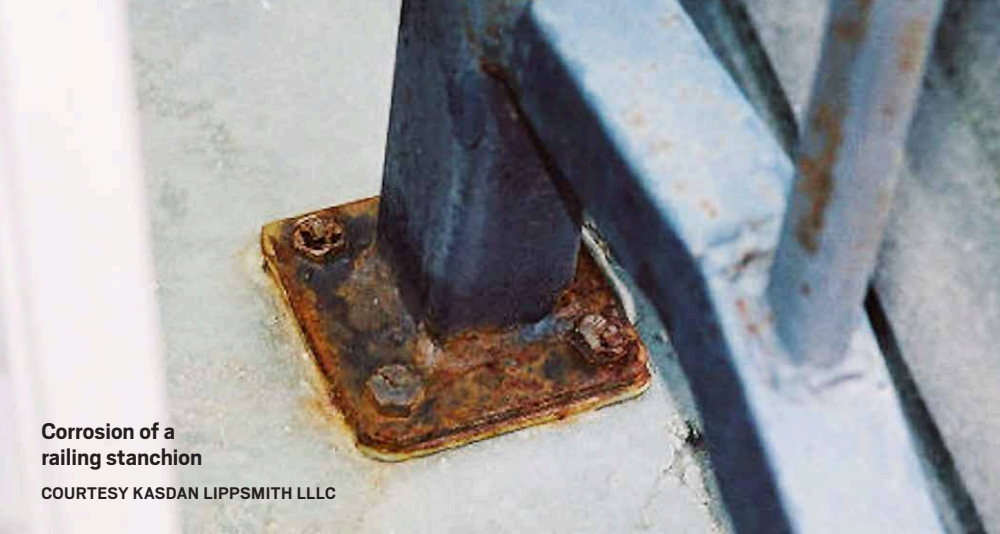
Corrosion of a railing stanchion

“Ocean air contains salts and chlorides,” notes Kasdan. Chlorides attack rebar, which then rusts, expands and cracks the surrounding concrete—a defect known as “spalling.”

Many concrete lanais and balconies at Hawaii’s hospitality properties—and their metal railings—fall victim to spalling. Concrete spalling problems can occur at the base of aluminum railing posts, typically due to rusting of the embedded reinforcing steel, and weaken the railing post.
